# Warning, Maintenance and Technical Alert

**The Issue:** As a result of wear over some years a major user of RegO A7575L4 Safety Hose Filler Couplings has found one instance where the retaining collar on the tailpiece of this coupling has worn away to the extent where the tailpiece has been allowed to travel through the handle assembly.

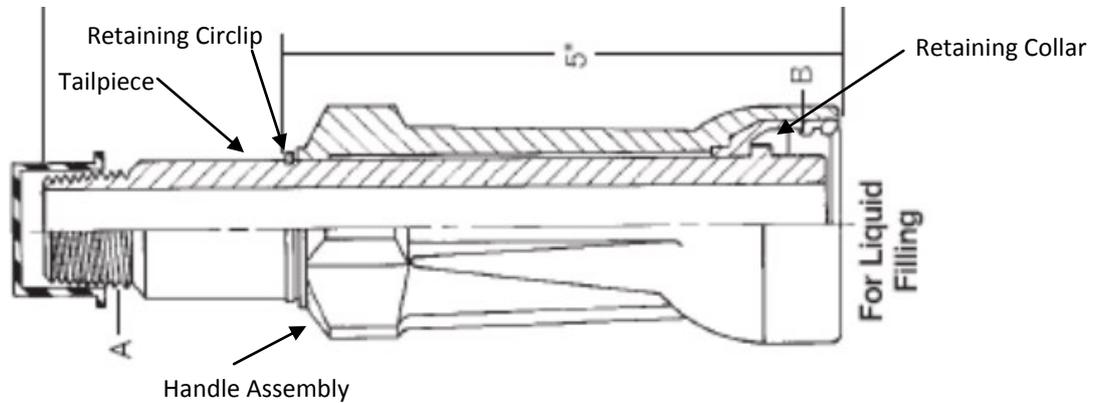
**Warning:** If the unit separates under pressure, that is during a filling operation, there is the potential for product discharge and operator injury.

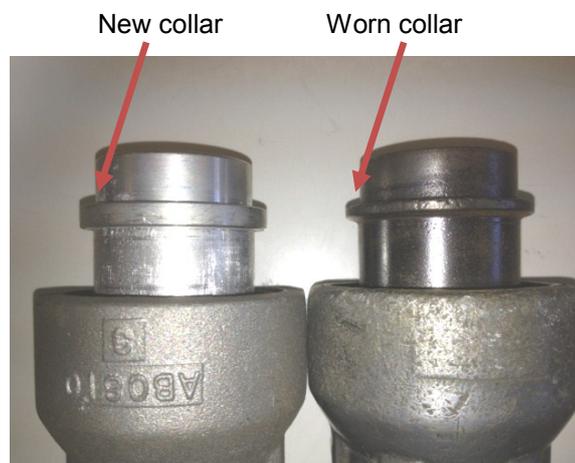
**What to do and what you might find:** Inspect by removing the retaining circlip from the tailpiece and slide the handle assembly back to reveal the collar. See examples below:

**How much wear is safe:** This issue has come to light over the last 72 hours and RegO has yet to consider and respond to the detail revealed. As soon as RegO has responded a further notice will be issued. It will be posted under 'News' at [gameco.com.au](http://gameco.com.au) and is expected early next week.
